CRITICAL CARE UNIT
IBN AL BITAR HOSPITAL
BAGHDAD, IRAQ

SIGIR-PA-06-066
SEPTEMBER 12, 2006

SUBJECT: Report on Project Assessment of the Critical Care Unit at the Ibn Al Hospital,
Baghdad Iraq (Report Number SIGIR-PA-06-066)

Critical Care Unit, Ibn Al Bitar Hospital Baghdad, Iraq

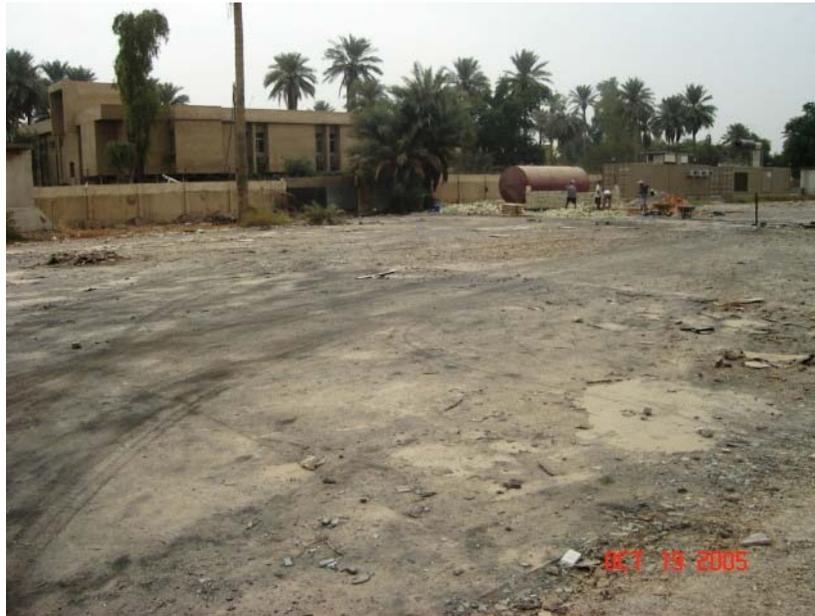
The description of the facility (pre-construction) was based on information obtained from the contract SOW and the USACE project file. The project site, located within the grounds of the Ibn Al Bitar Cardiac Hospital, in Baghdad, Iraq, was also the location of the previous CCU. The looters, who completely destroyed the previous CCU, left nothing standing with only the concrete foundation and ground floor

concrete slab remaining. Site Photo 1 shows the clinic site and parts of the ground floor concrete slab.

Site Photo 1. Old and new site of the Ibn Al Bitar Hospital Cardiac Care Unit (Photo provided by USACE)

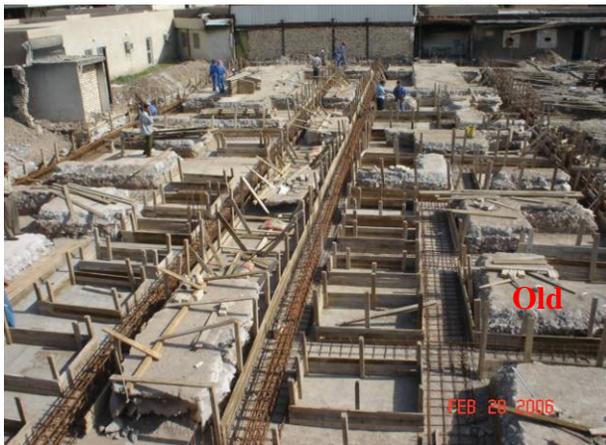
The CCU building structural design required a reinforced concrete frame supported by a foundation consisting of isolated pad footers, wall footings, and interconnecting tie-beams. Prior to placement of the footers, the concrete foundation from the previous building needed removal. The contractor removed the existing foundation as the new foundation was constructed. Site Photo 2 shows some of the remaining foundation as well as the form work and reinforcing steel placement for the new tie beams and wall footings. Site Photo 3 shows the completed foundation including tie-beams and wall footings, and some of the previous concrete foundation remaining. According to the DRE, the contractor subsequently removed all of the concrete comprising the previous foundation. Based on our review of the Government Quality Assurance (QA) reports, the construction of the foundation occurred without any known deficiencies.

Site Photo 2 - Wall footings and tie beams under construction (Photo provided by USACE)

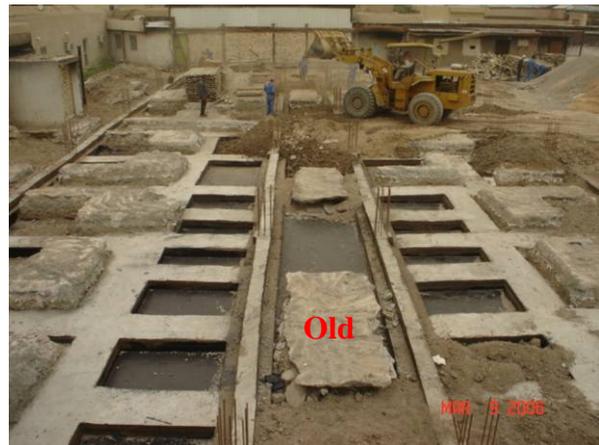
Site Photo 3 - Completed wall footings and tie-beams (Photo provided by USACE)

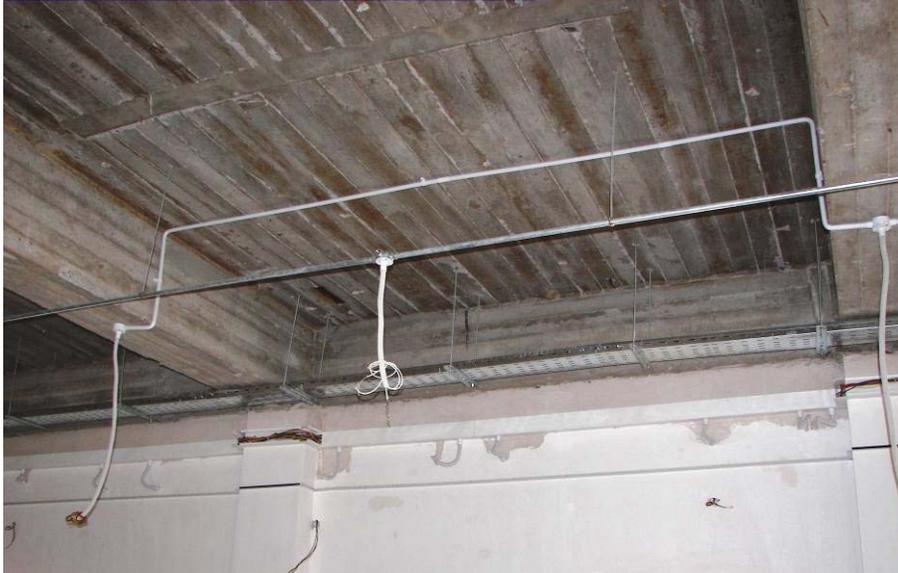
The above grade structural frame supporting the reinforced concrete floor and roof slabs consisted of a network of reinforced concrete columns and beams. The design called for beams 40 centimeters (cm) in width by 50 cm in height, with various reinforcing steel configurations, depending on the location within the span. The 40 cm x 40 cm columns contained vertical reinforcing bars and lateral reinforcing ties. Prior to concrete placement, the USACE QAR found some problems with the beam

reinforcing steel. The QAR documented areas where the steel was not spaced correctly. The QAR also found places where the horizontal and vertical reinforcing were not aligned properly. Based on verbal confirmation from the USACE DRE, these deficiencies were corrected by the contractor.

At the time of the site visit, the suspended ceiling had not been completely installed so the assessment team could see the upper portions of the ground floor columns and beams. We did not observe any noticeable defects with the concrete workmanship such as honeycombing, segregation, or exposed reinforcing steel. Site Photo 4 shows some of the structural concrete work at the CCU.

Site Photo 4. Structural concrete supporting the first floor

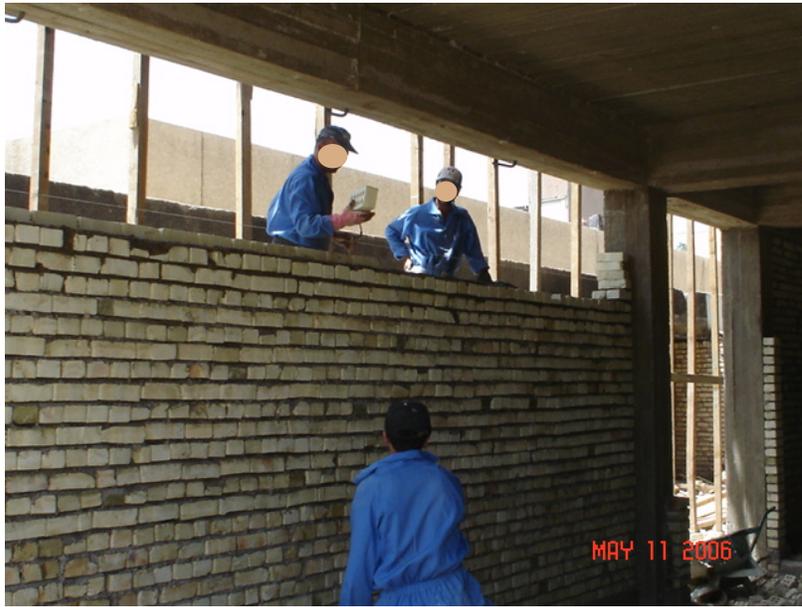
The BOQ listed a requirement to use clay bricks for the ground floor walls. The design required a wall thickness of 24 cm for the exterior and interior walls, except the public bathrooms, which were required to be 12 cm thick. The design required the exterior walls to be plastered with a cement mortar and rendered with a textured finish. The surface finish requirement for interior walls included gypsum plastering and painting. Based on a review of the Quality Assurance reports, it appears the contractor adequately constructed the brick interior and exterior walls to meet the design requirements. Site Photo 5 shows an example of the brick work prior to plastering and Site Photo 6 shows one side of the CCU after the walls were plastered and rendered.

Site Photo 5. Exterior wall brick work (Photo provided by USACE)

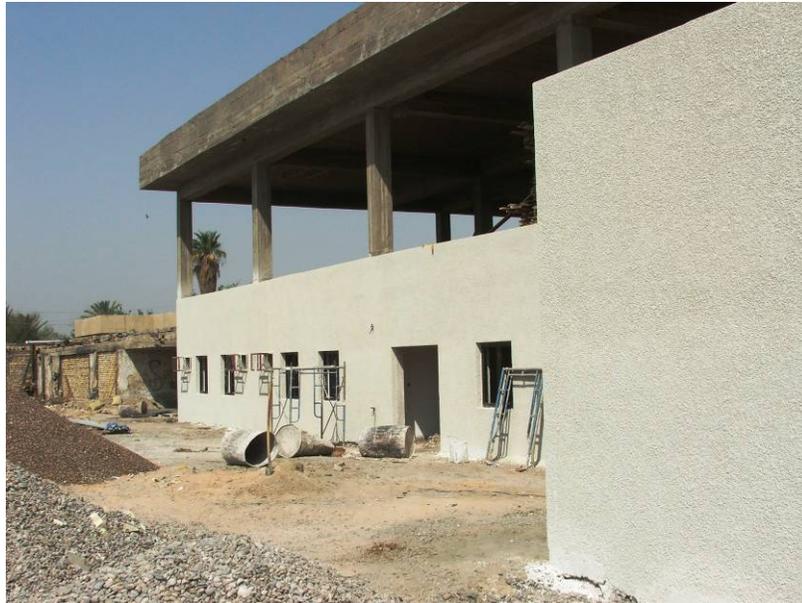
Site Photo 6. Exterior walls of the CCU after plastering and rendering.

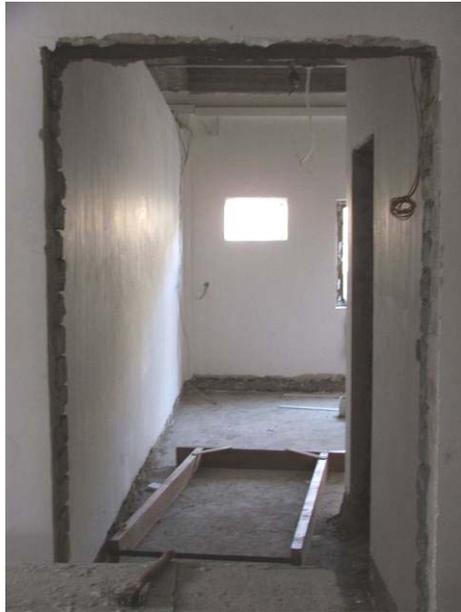
At the time of the assessment, the patient room walls had been plastered and painted. The contractor had also completed the installation of ceramic tile on the bathroom walls. The flooring and ceilings were not yet installed in any of the patient rooms including the bathrooms. Window frames were in place, but the glass was not yet installed. The frame for the window HVAC unit was in place, but the unit was not yet installed. The contractor was in the process of installing door frames. The contractor also began to rough-in plumbing for the toilets, wash basins, and showers. Site Photos 7 and 8 show the ongoing construction in one of the patient rooms. Site Photo 9 shows the above ceiling water lines and exhaust system ductwork for one of the bathrooms.

All observed work in the patient rooms and doctors' room and their adjoining bathrooms appeared to meet the standards of the design. We did not find any noticeable defects associated with the quality of workmanship.

Site Photo 7. Patient room looking from entrance

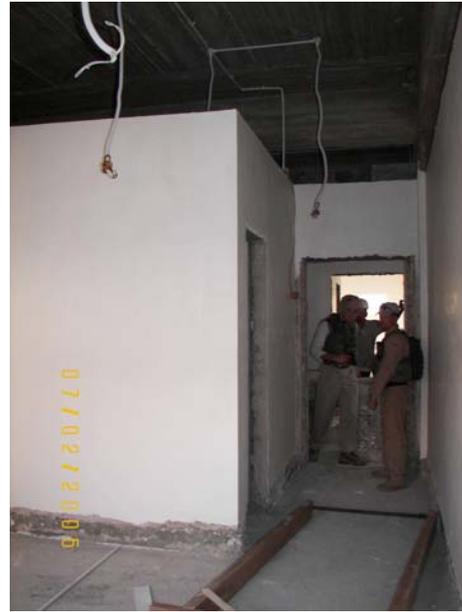
Site Photo 8. Patient room looking towards entrance

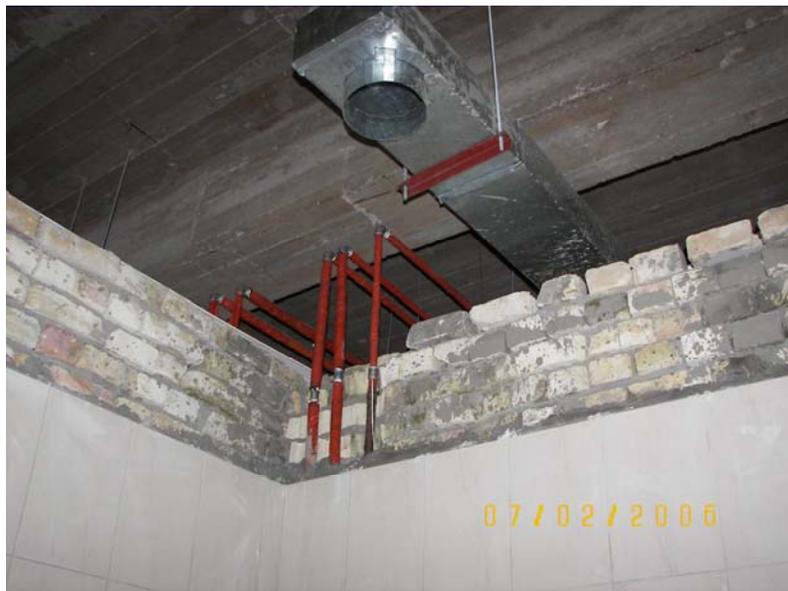
Site Photo 9. Water lines and exhaust system ductwork above one of the patient bathrooms

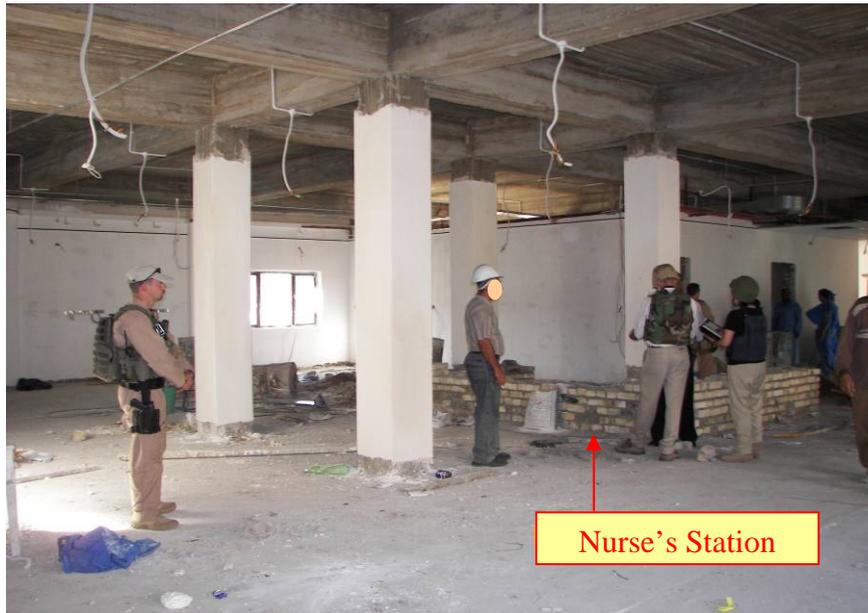
At the time of our assessment, the contractor had completed plastering and painting the exterior walls. Aluminum window frames were installed. Electrical conduits were in place, and the contractor was in the process of pulling wire to recessed boxes for outlets and switches. Site Photo 10 shows part of the open ward observed during the site visit.

Site Photo 10. Ward area under construction.

In addition to the building components, the contractor was also constructing a brick reception table base (Site Photo 10) for the nurse's station in the open ward area. The BOQ required a ceramic tile finish for the table.

Based on our observations, the work to date in the ward area appeared to meet the standards of the design.

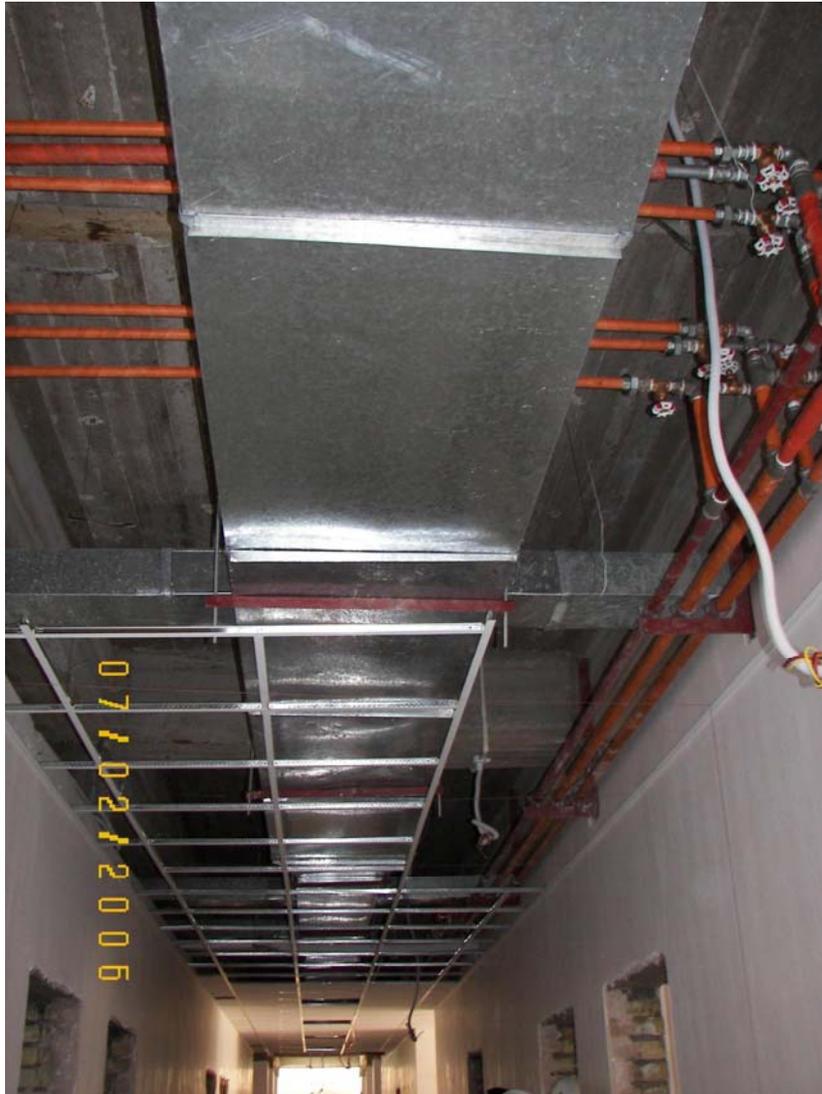
The CCU contained a central corridor (21.6 m in length) providing access to the patient rooms and the ward area. The corridor also provided an access way for the utilities (water, exhaust, and electric), located above the suspended ceiling. Site Photo 11 shows the water lines, the exhaust system ductwork, and the electrical drops installed by the contractor, as well as part of the suspended ceiling grid. The water supply system consists of three lines of various diameters [15 – 50 millimeters (mm)] of schedule 40 galvanized steel pipes for cold water, hot water, and re-circulated hot water. No noticeable defects were found with the installation of these utilities and the quality of workmanship appeared adequate.

Site Photo 11. Utility installation above corridor suspended ceiling.

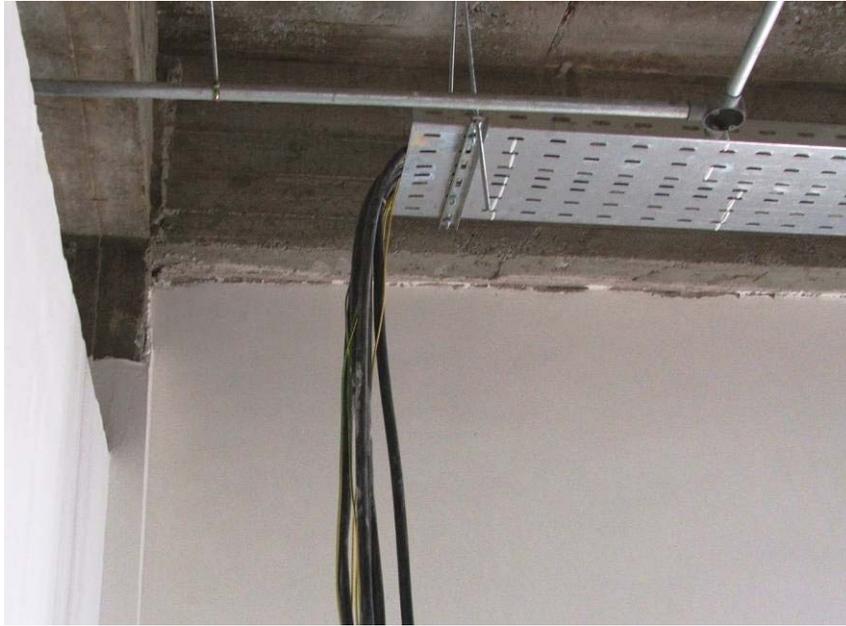
The design included an interior electric room. However, the electrical drawings provided to the assessment team did not show the location of the main electrical distribution panel and two sub-distribution panels that were listed in the BOQ. When we inspected the electrical room, the walls in the room were plastered and painted. The aluminum cable tray was installed and anchored to the concrete slab above the room. One of the contractor's employees indicated to us the location of the main distribution panel inside the electrical room. The contractor was running cable on the cable tray to the panel location as shown in Site Photo 12.

Site Photo 12. Cable tray and cable to connect the main distribution panel.

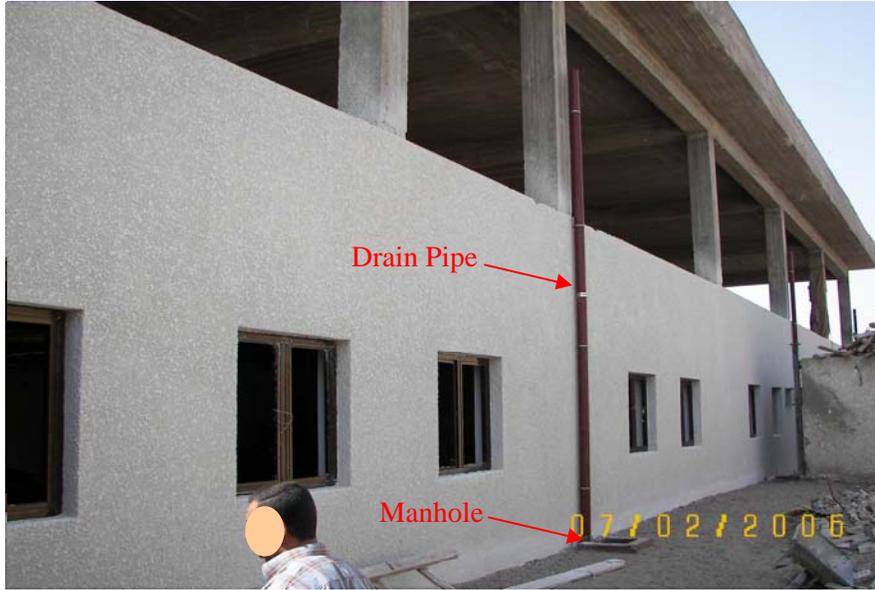
The BOQ listed a requirement for 80 linear meters of 100 mm (diameter) cast iron downspouts. The architectural drawings show the location of the seven roof drains along the column lines for the building. During the exterior inspection, we observed the cast iron downspouts in the locations noted on the design along the column line. We also noted the downspouts drained directly into the manholes, as shown in Site Photo 13, although the design drawings did not provide details showing the downspouts or connections into manholes.

Site Photo 13. CCU exterior with downspout feeding into sewer manhole.

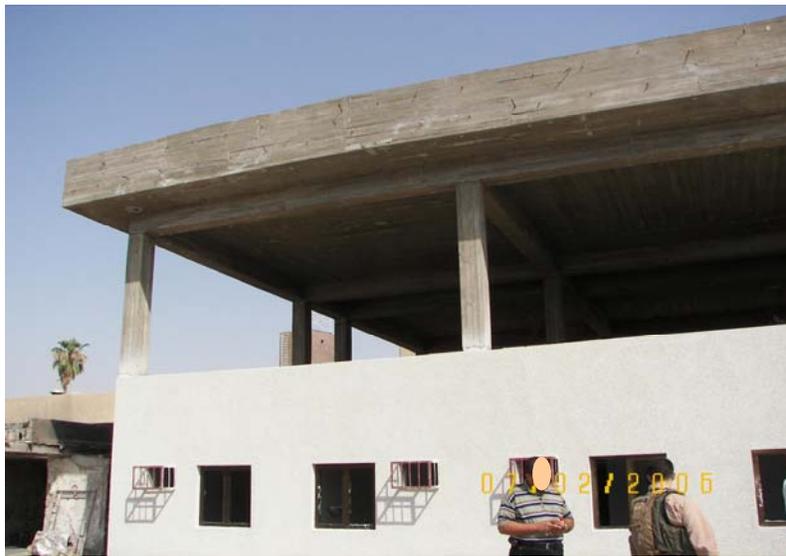
The assessment team planned to inspect the first floor and roof. However, because of recent activity in this area of Baghdad, security concerns prevented the team from going up to the first floor and to the roof. From the ground, we did walk around the building and looked at the exterior columns and beams of the first floor and roof parapet. We did not observe any noticeable defects associated with the concrete workmanship. Site Photo 14 shows the first floor and roof structural concrete work.

Site Photo 14. First floor columns and beams supporting roof
