# SIGIR Oversight

## SIGIR INSPECTIONS

This quarter, SIGIR inspection teams continued to conduct inspections and assessments of reconstruction projects throughout Iraq to determine and report on the adequacy of work planned and accomplished. SIGIR has now completed 42 project assessments and 97 limited on-site inspections.

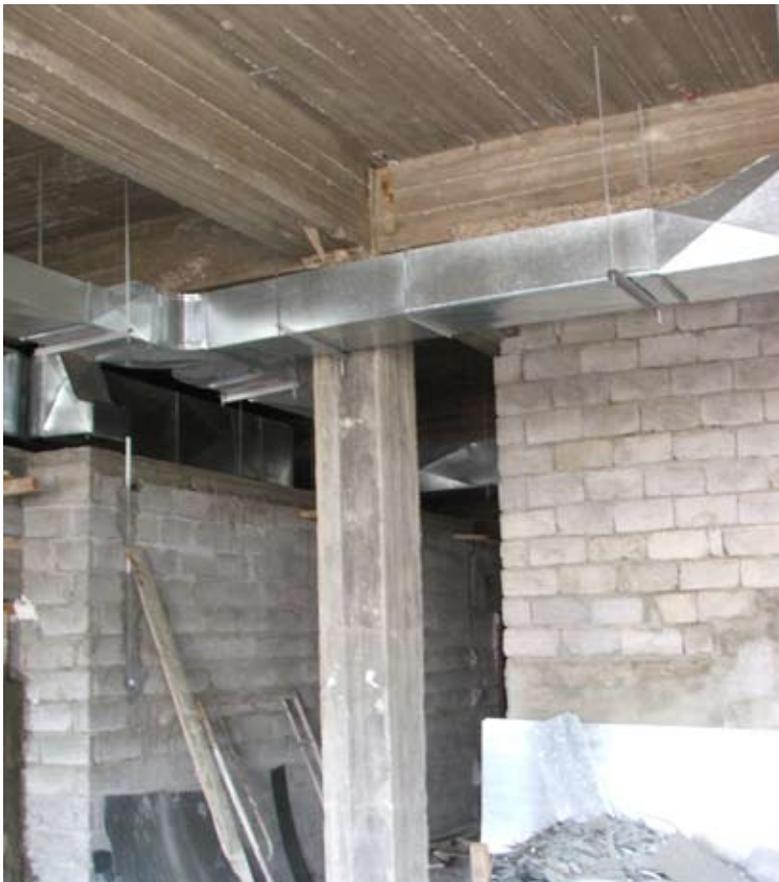
Reinforced load-bearing column out of plumb

SIGIR identified concrete segregation, voids, rebar exposure on the surface of the load-bearing reinforced concrete ceiling beams, and columns with chipped concrete. A reinforced load-bearing column was noticeably out of plumb. Also, SIGIR identified many defects in workmanship of the non-load-bearing walls, such as gaps in the walls and improper and uneven brick placement. Instead of correcting each defect, the walls were plastered over with gypsum. In one instance, a concrete stairwell was in place; however, the workmanship of the concrete was poor. The surface was uneven, small pieces of the stairs were chipped off, and concrete segregation was visible on the side and underneath the stairwell. Furthermore, a lintel—a load-bearing support above windows and doors—was not properly installed.

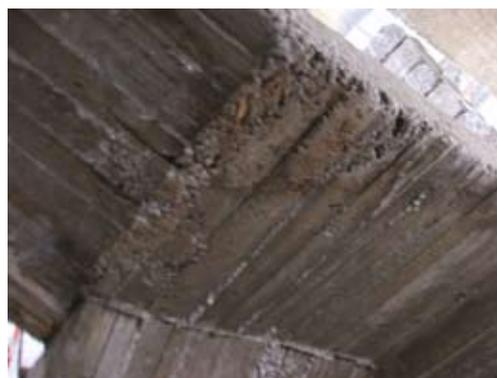
Concrete segregation on underside of reinforced concrete stairwell

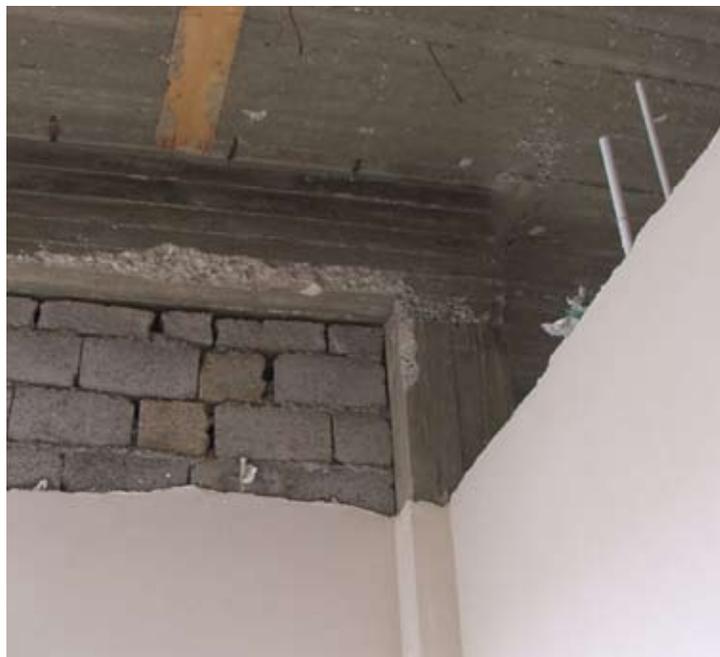
Segregation of load-bearing reinforced concrete ceiling beam

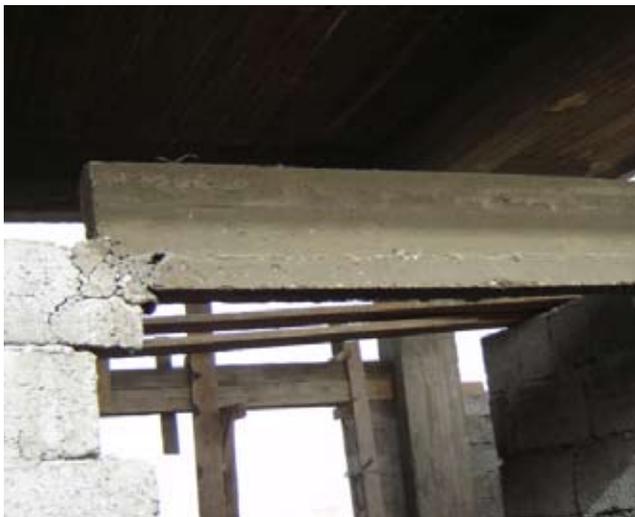
Improperly installed lintel

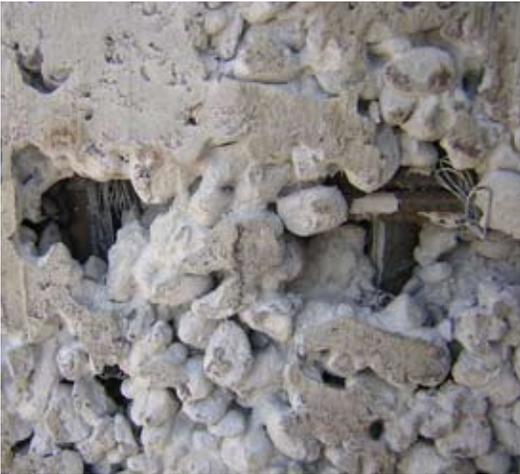
Honeycombing and exposed rebar in concrete—photo provided by U.S. Army Corps of Engineers

This \$1.3 million project has three unresolved issues associated with the design and construction that required management attention. Two of the three pertain to the concrete construction. The structural concrete had problems with honeycombing<sup>12</sup> and exposed rebar in columns and shear walls, particularly in locations on the first level. As a result, there are concerns regarding the structural integrity of the building. The contractor conducted

The other concrete issue is related to the corrective action taken by the contractor to repair the honeycomb areas. The contractor repaired these areas utilizing a rich cement-sand patch, instead of using a recommended epoxy grout patching material to repair the voids. It remains a durability issue that must be resolved by USACE and the contractor.

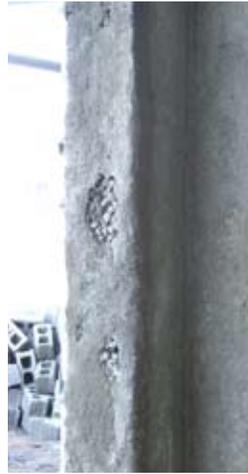
Honeycombing after surface coating

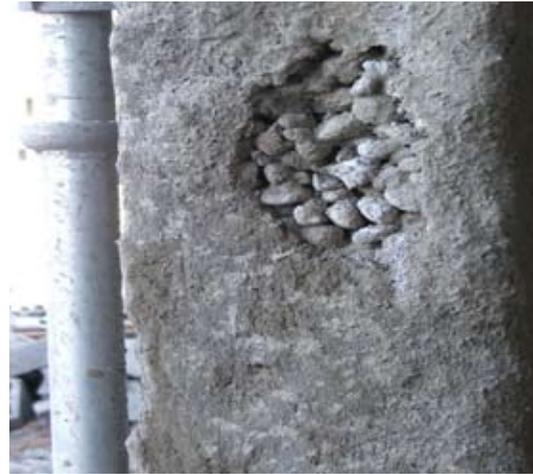
Close-up of honeycomb area

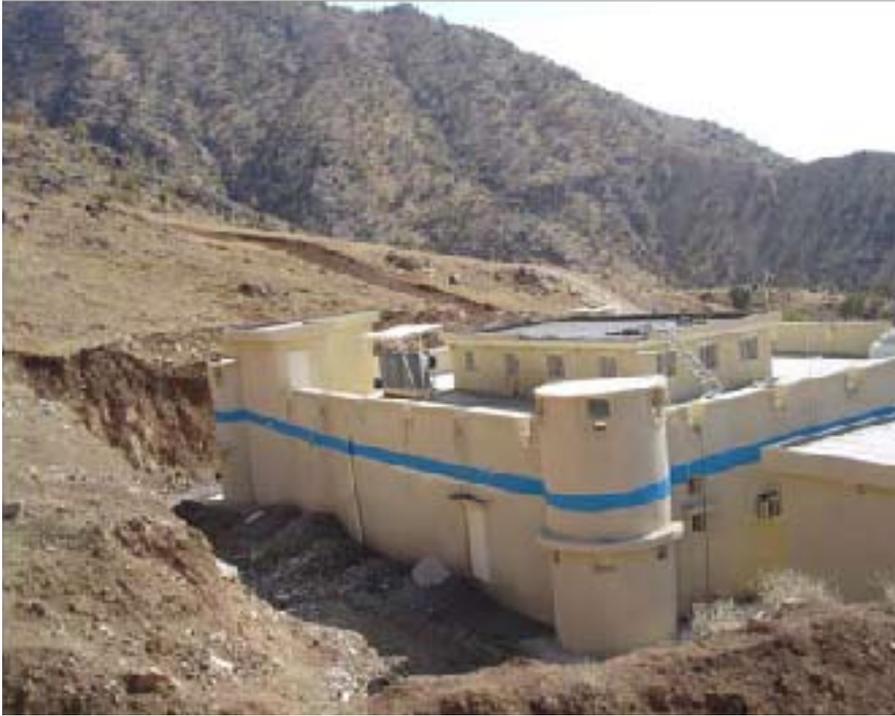
Cut bank with no stabilization at border post

eter security systems, gates, berms, or walls installed. Concrete quality was sometimes poor, and inconsistent surfaces in concrete and plaster finishing were common in the buildings and other structures. Numerous sites lacked retaining walls to prevent degradation of the embankments created by site leveling.

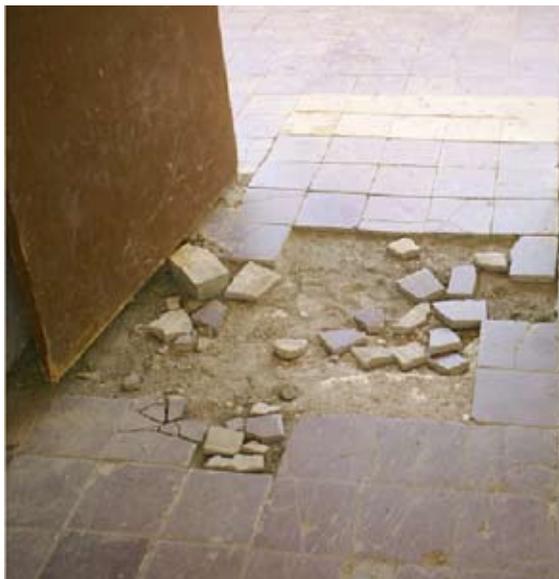
The quality of workmanship at the three schools assessed appears low. Materials used appeared to be substandard, although the contract required industrial-type equipment. Renovation was superficial in some areas, as demonstrated by painting interior and exterior walls without first repairing the walls. At the time of the ground survey, the schools were still in need of significant work.

Broken tiles in school classroom

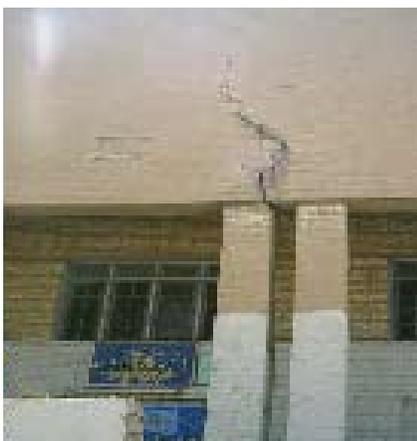
Cracks in school's outer wall

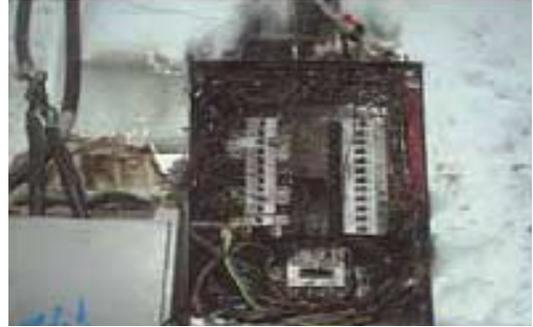
Electrical circuit breaker panel with burn mark

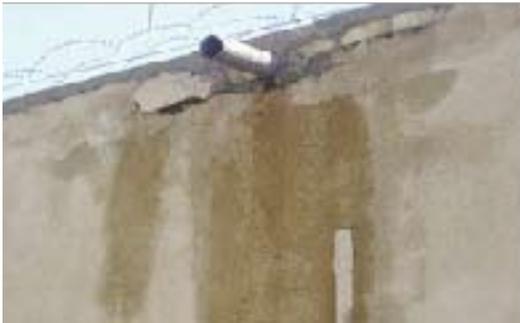
Deteriorating parapet around exterior roof drain

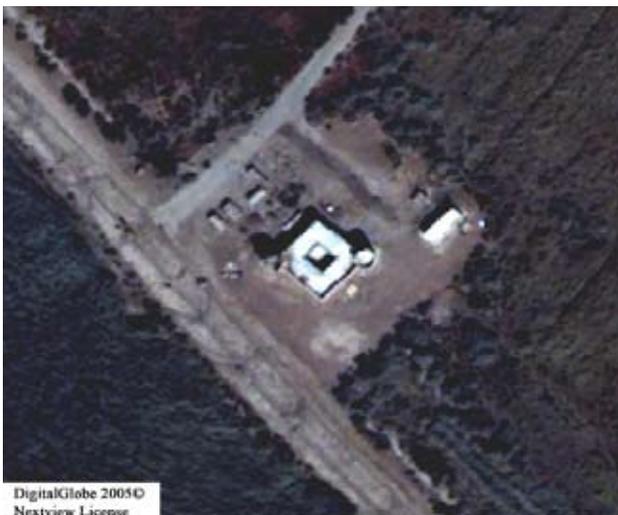
Image 3. Example of imagery provided this quarter by NGIC helping to confirm locations of border forts in Iraq. Pictured above is a border fort in the southern region of Iraq near the Iraq-Iran border. A visual assessment of the imagery provided shows no visual indicators that the border fort does not meet contract specifications.

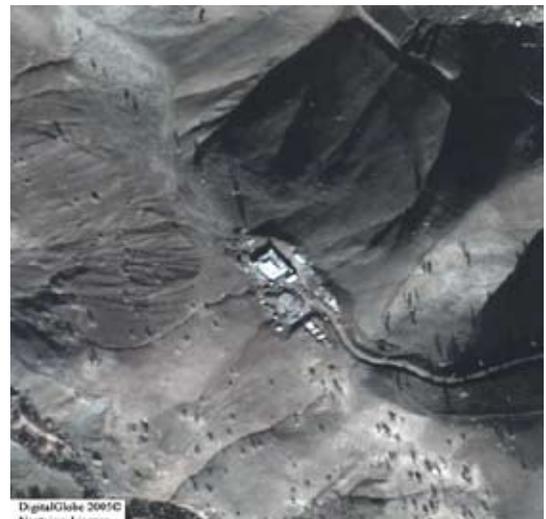
Image 4. Example of imagery provided this quarter by NGIC. Pictured above is a completed border fort in the northern region of Iraq on the Iraq-Iran border. A visual assessment of the imagery shows no visual indicators that the border fort does not meet contract specifications.

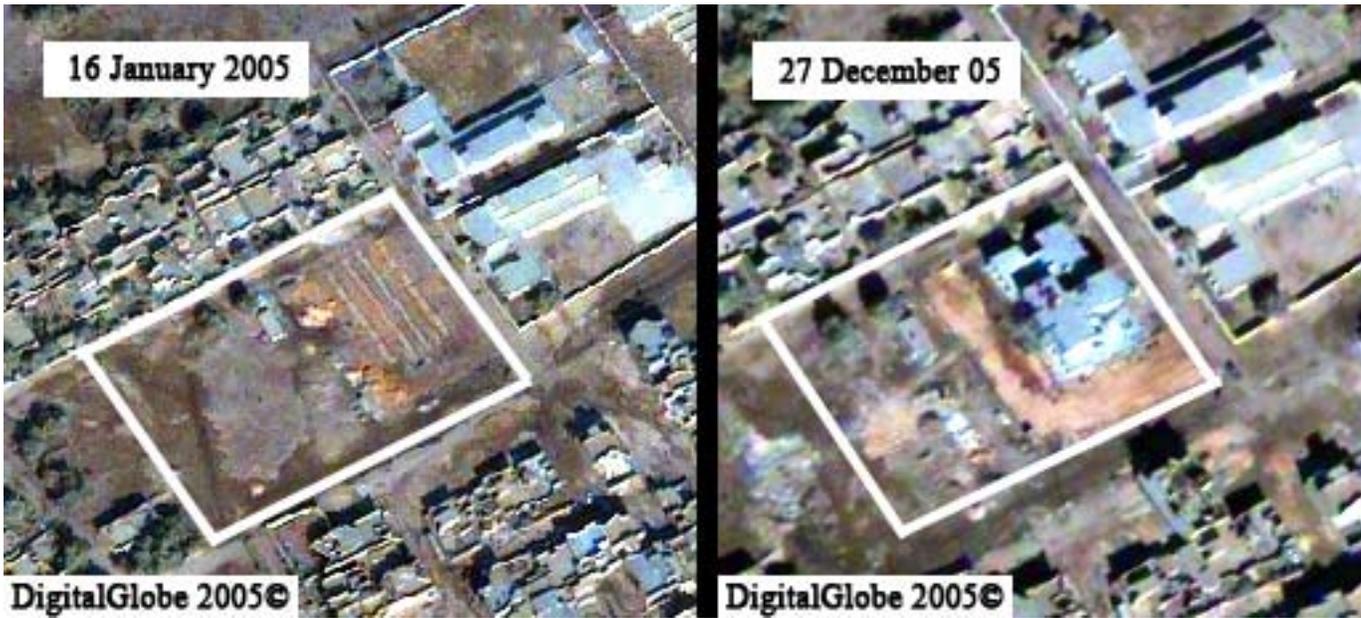
Images 5 and 6. Comparison of imagery showing progress made at a public health clinic in southern Iraq between January 16, 2005 (left) and December 27, 2005 (right). The image on the left shows the initial ground preparation for construction. The image on the right shows the final leveling of soil around the clinic, which was noted as a deficiency in an earlier Ground Project Survey visit.
