KIRKUK CANAL CROSSING
KIRKUK, IRAQ

SIGIR PA-05-011
MARCH 7, 2006

Special Inspector General for Iraq Reconstruction

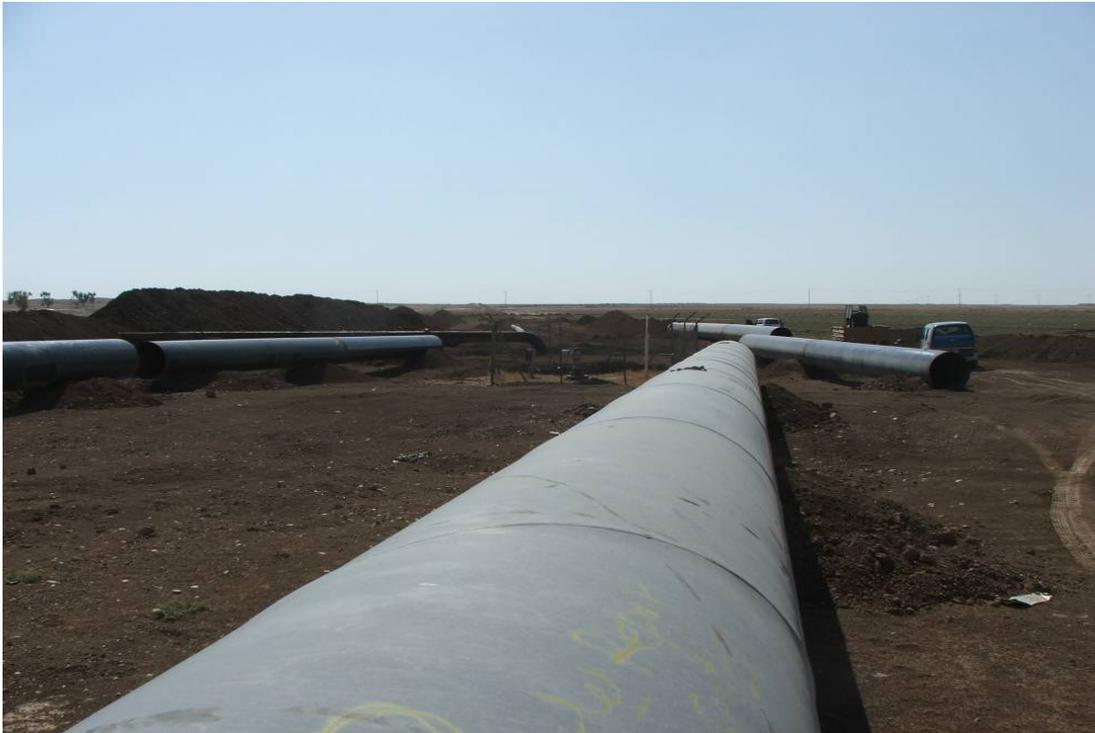
The 40-inch diameter with 0.688-inch WT pipe will be used for the canal crossing itself, including the length required to the ball valve location. The PIJV has completed an inventory and has determined that the amount is sufficient to accommodate the proposed pipeline routing. The valves and flanges were inspected by PIJV and found to be in good condition.

Site Photo 1: Pipes Purchased By Prior Contractor

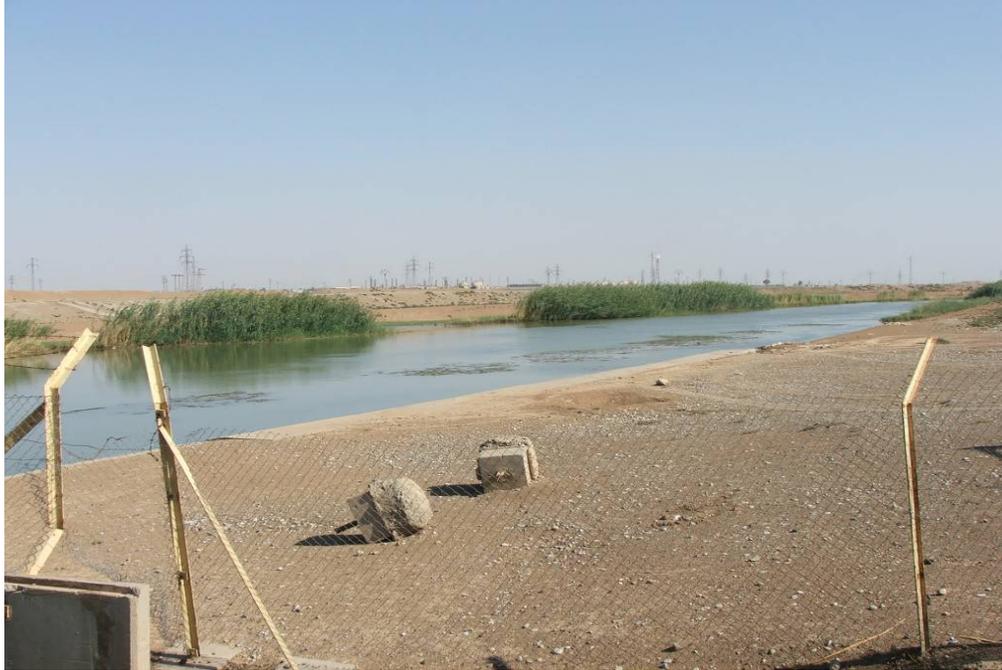
Site Photo 2: Kirkuk Irrigation Canal

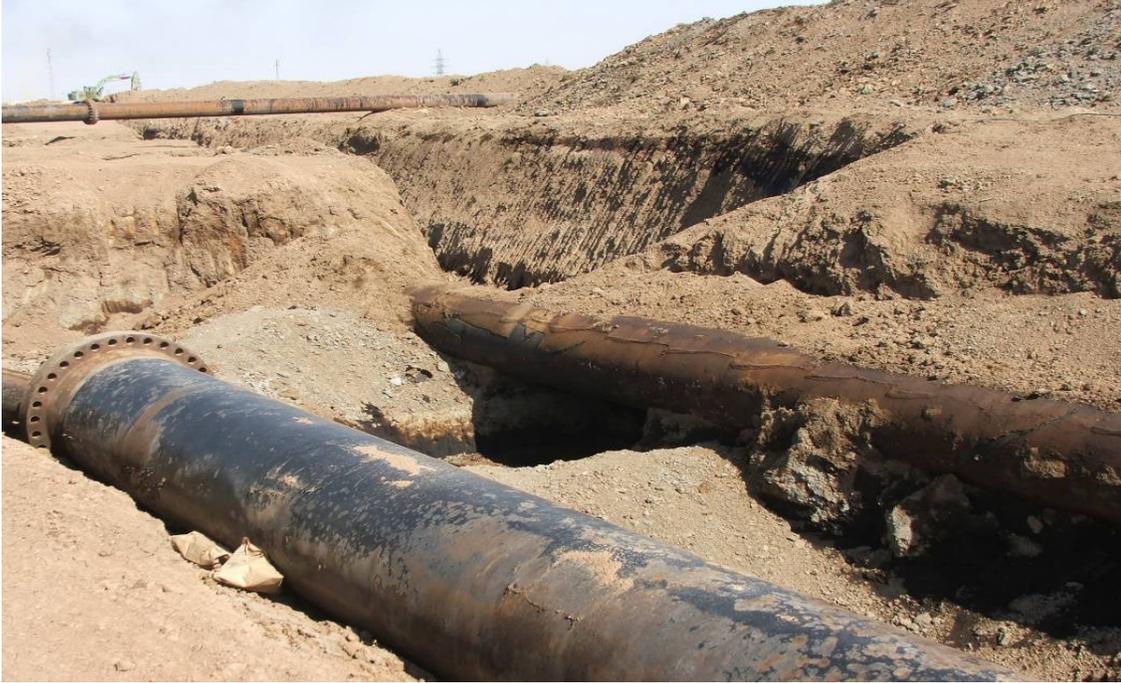
During the site visit, the assessment team verified that the excavation of the trenches was progressing. While most of the excavation for the pipeline trench was complete, a few areas required additional excavation to straighten the trench to comply with contract specifications. The trench was estimated to be about 750 m in length and approximately eight to ten feet in depth. Old pipelines were encountered in the pipeline trench, so the excavation was adjusted accordingly. Oil was observed seeping from the ground or leaking from other pipes and accumulating in the pipeline trenches, on the soil, and on top of the standing water. Procedures were implemented by the subcontractor to mitigate the hazards of toxic fumes to the workers and the fire hazard of flammable materials near welding activities. The subcontractor was observed pumping oil out of the excavations at the time of the site visit. Site Photo 3

Site Photo 3: Pipeline Excavation Work

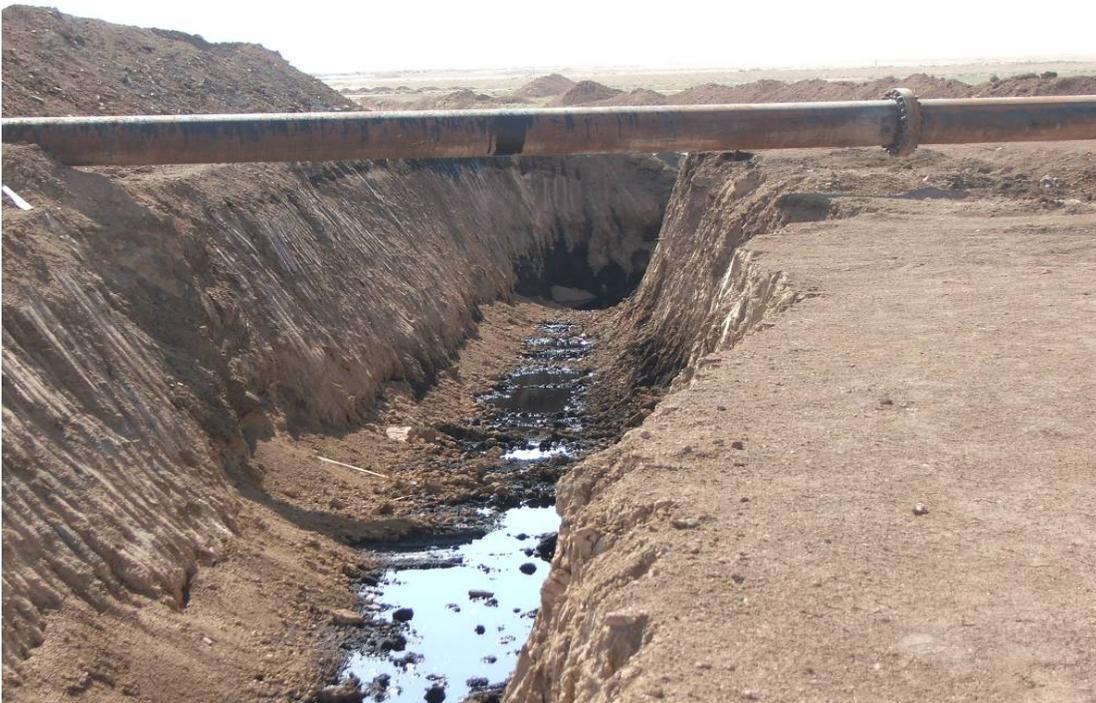
shows excavation of trenches for placement of the pipeline. Site photo 4 shows excavation of soils in the culvert crossing the KIC. Site photo 5 shows excavations with oil seeps.

Site Photo 5: Common Example of Pipeline Excavation with Oil Seepage

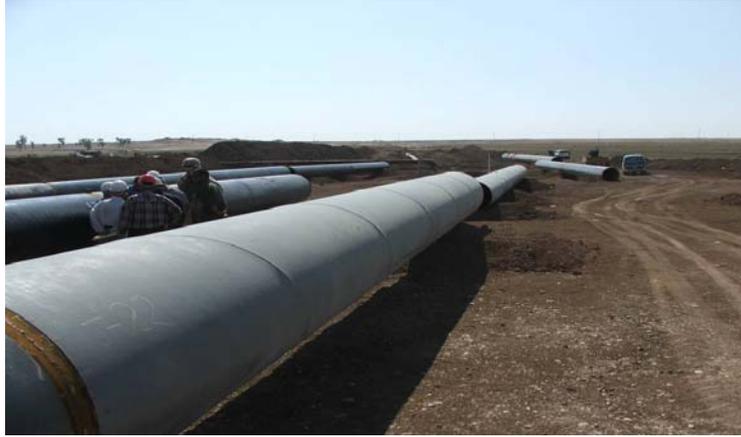
During the site visit, the assessment team observed that the fabrication of the pipeline was in progress. The subcontractor was fabricating and connecting pipeline sections on both sides of the canal. The fabrication of the bridge section pipeline had not begun at the time of the site visit. The assessment team noted that some of the pipeline had been marked for repair with corrosion control epoxy coating. Radiography testing was not observed during the site visit. Site photo 6 shows pipe sections on site before placement into excavations. Site photo 7 shows a weld connecting two pipeline sections. The fabrication of the pipeline appeared to be consistent with contract and design requirements.

Site Photo 6: Pipe Section on Site before Placement into Excavations.

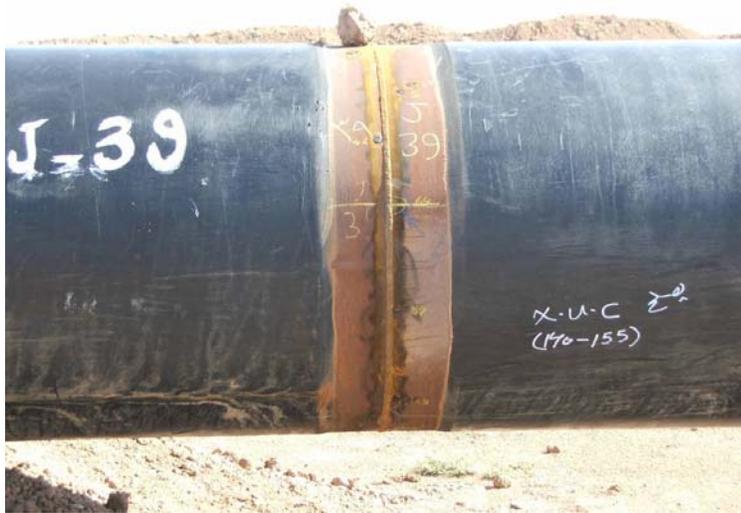
Site Photo 7: Weld Connecting Two 40-Inch Pipe Sections.

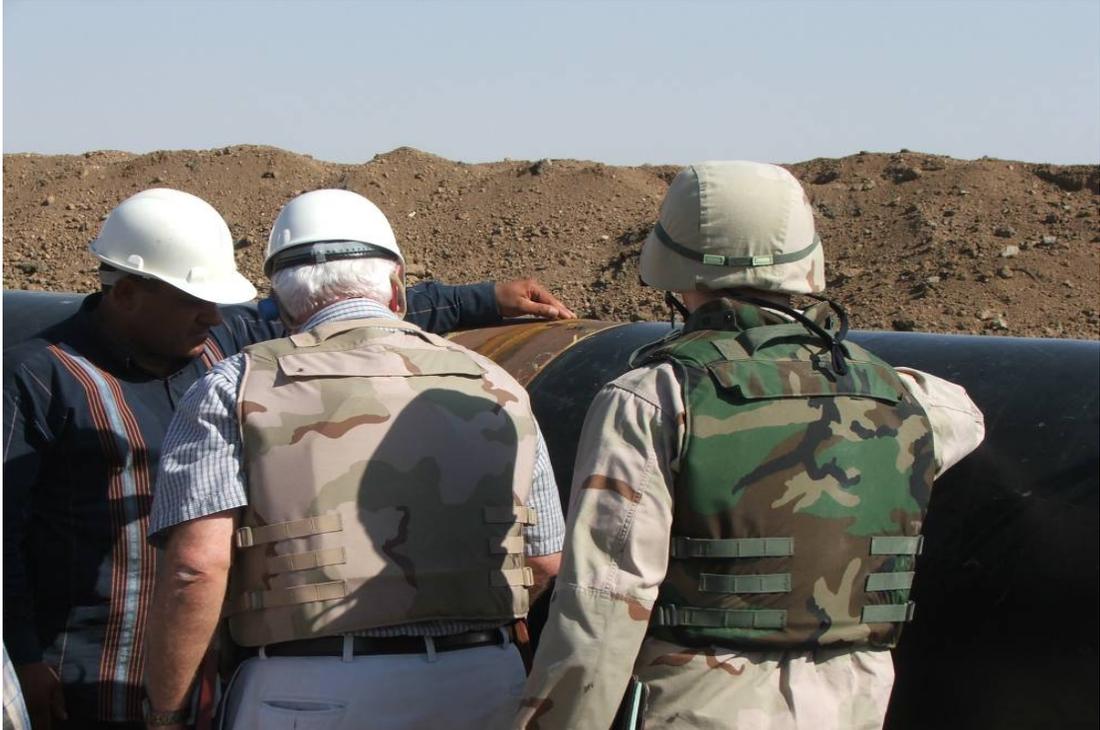
During the site visit, the assessment team observed the contractor's QC Manager effectively working with the subcontractor's QC Inspector and other subcontractor supervisors. In one instance, the contractor's QC Manager pointed out welding and pipe cover problems. The message was presented in a positive manner and it appeared that the subcontractor's QC Inspector became more aware of the expected quality level. Site Photo 8 shows a subcontractor's QC inspector, contractor's QC manager and QAR discussing a weld that needs rework.

Site Photo 8: Subcontractor QC Inspector, Contractor's QC Manager, and QAR Discuss a Weld That Needs Rework

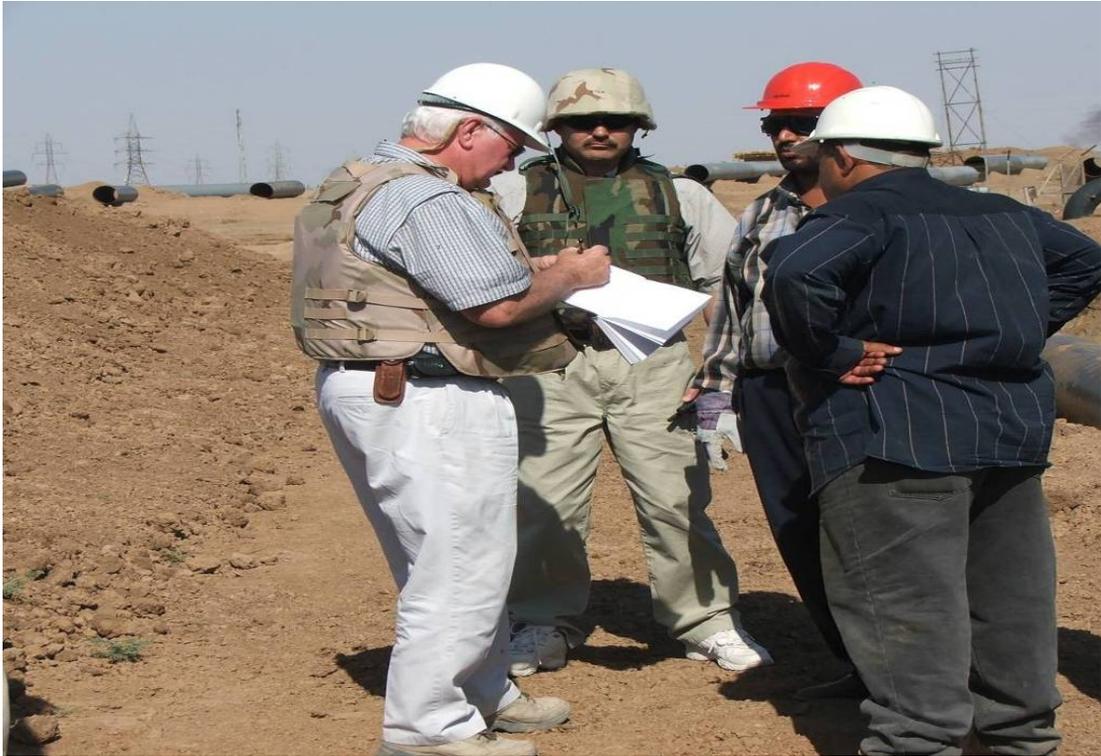
In another instance, we observed the contractor's QC Manager discuss a pipe placement problem with subcontractor personnel. Specifically, oil that seeped into the pipeline's excavation presented a fire and safety hazard to welders and construction workers. To ensure safety and quality workmanship, the contractor's QC Manager explained how to place clean sand and a heavy duty plastic material (tarp) in the excavation to form a protective barrier between the oil and workers. Site Photo 9 shows a contractor's QC manager explaining how to place protective liner in the pipeline excavation.

Site Photo 9: Contractor's QC Manager Explains How to Place Protective Liner in the Pipeline Excavation
