# SIGIR Oversight

## SIGIR INSPECTIONS

This quarter, SIGIR inspection teams continued to conduct inspections and assessments of reconstruction projects throughout Iraq to determine and report on the adequacy of work planned and accomplished. SIGIR has now completed 42 project assessments and 97 limited on-site inspections.

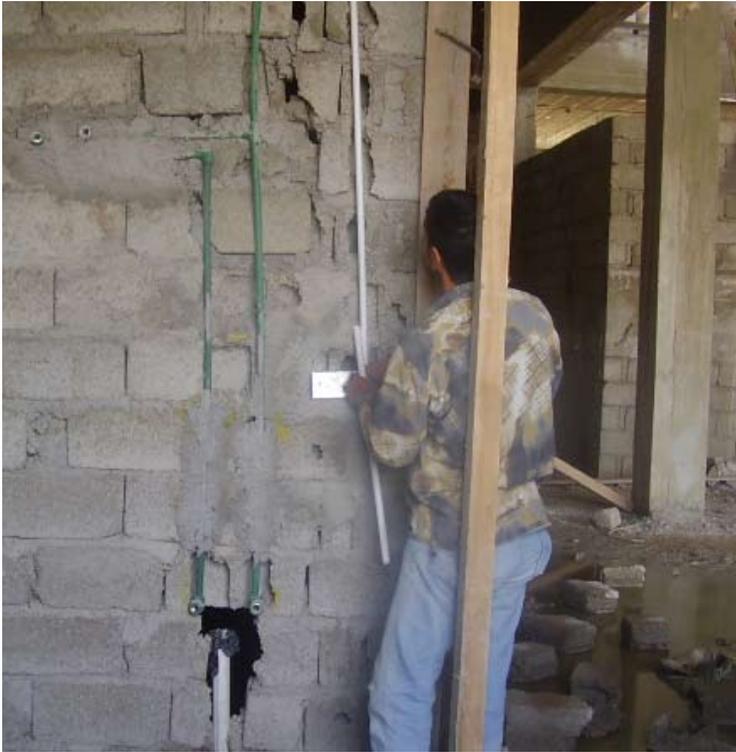
Example of concrete block work for non-load-bearing walls

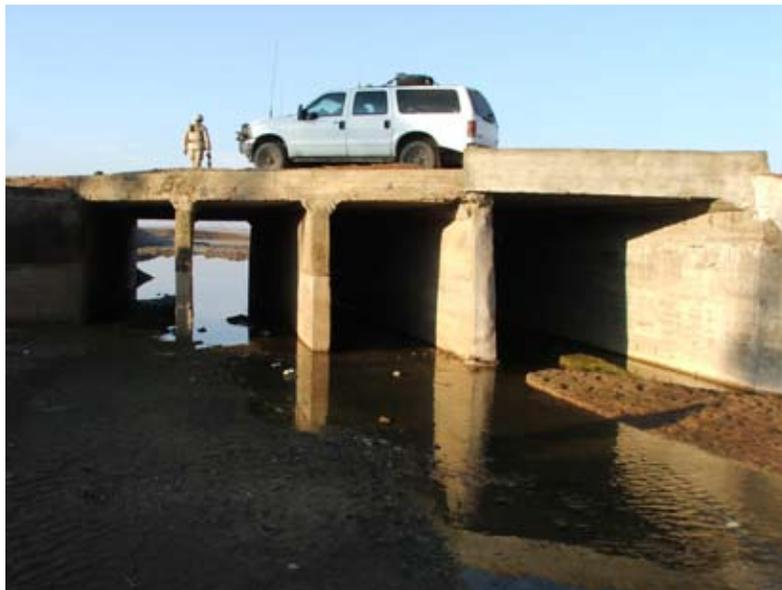
Although construction appeared to meet the standards, the SIGIR team found problems with the design drawings. The design included only basic cut-and-fill roadway cross-sections, typical details on reinforced concrete pipe culverts, curbs, and retaining walls, but no details on box culverts. Further, there were no drawings showing the plan views of the road-

Extension of existing box culvert

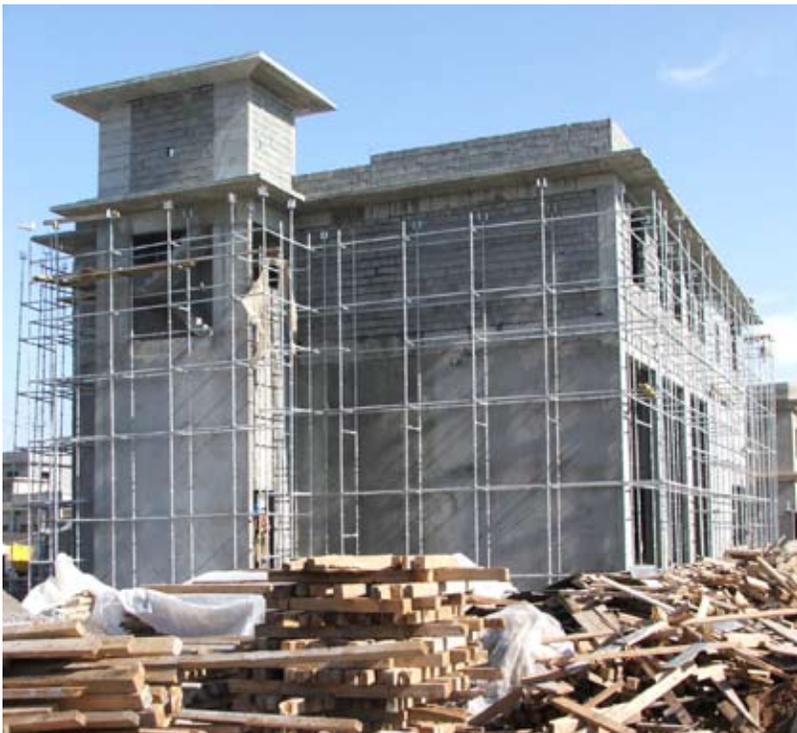
This \$1.3 million project has three unresolved issues associated with the design and construction that required management attention. Two of the three pertain to the concrete construction. The structural concrete had problems with honeycombing<sup>12</sup> and exposed rebar in columns and shear walls, particularly in locations on the first level. As a result, there are concerns regarding the structural integrity of the building. The contractor conducted

Exterior view of the Ainkawa Fire Station

The other concrete issue is related to the corrective action taken by the contractor to repair the honeycomb areas. The contractor repaired these areas utilizing a rich cement-sand patch, instead of using a recommended epoxy grout patching material to repair the voids. It remains a durability issue that must be resolved by USACE and the contractor.

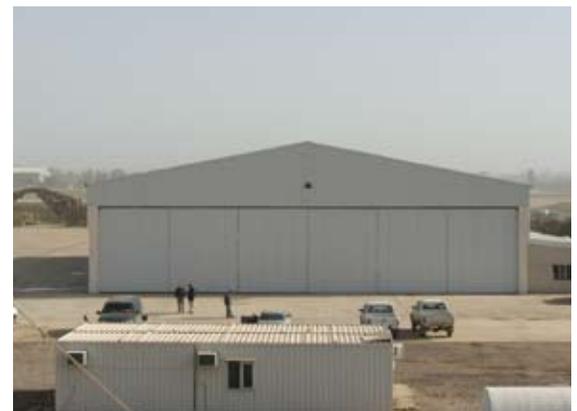
At the time of the SIGIR assessment, construction was complete on the hangar, and there was a pending list of deficiencies to be repaired under warranty. SIGIR found problems, such as leaks at the windows and discrepancies with the plumbing, electrical system, and general workmanship. The contract did contain requirements for final inspections and warranties, which should resolve the construction deficiencies identified.

Exterior view of aviation hangar

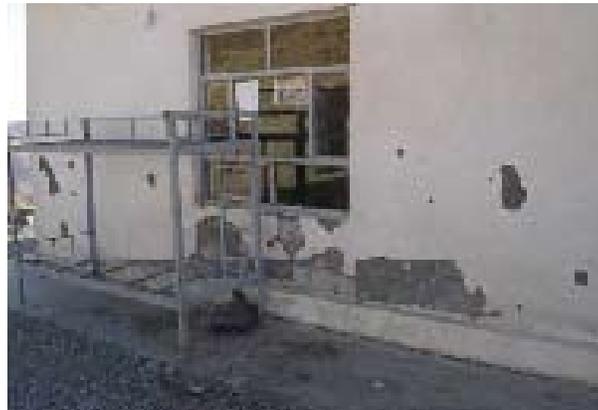
Exterior wall of border post

eter security systems, gates, berms, or walls installed. Concrete quality was sometimes poor, and inconsistent surfaces in concrete and plaster finishing were common in the buildings and other structures. Numerous sites lacked retaining walls to prevent degradation of the embankments created by site leveling.

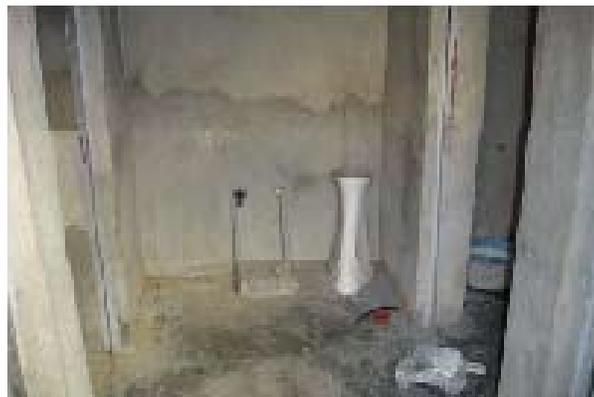
Bathroom fixtures at border post

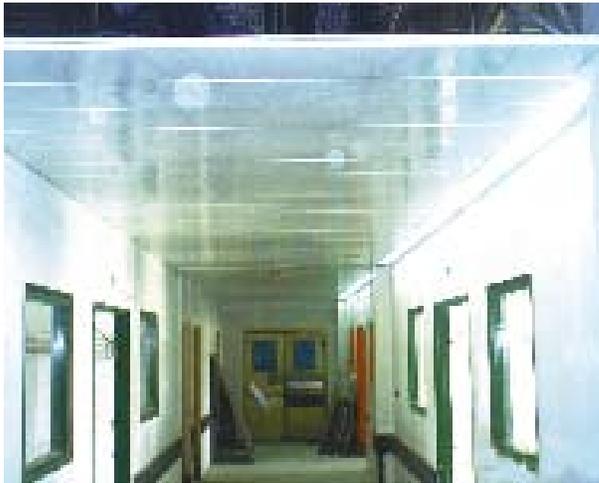
Renovated hallway at one hospital project

At the time of the SIGIR site visits, renovations were ongoing at both hospitals. Based on a review of the project surveys, SIGIR noted no significant deficiencies. Minor deficiencies include poor interior finish, staining on the ceiling and floors (indicating water leakage, either from pipes or from the roof), floors requiring repair, and power cables inappropriately passing through a window into the electrical room at one of the hospitals.

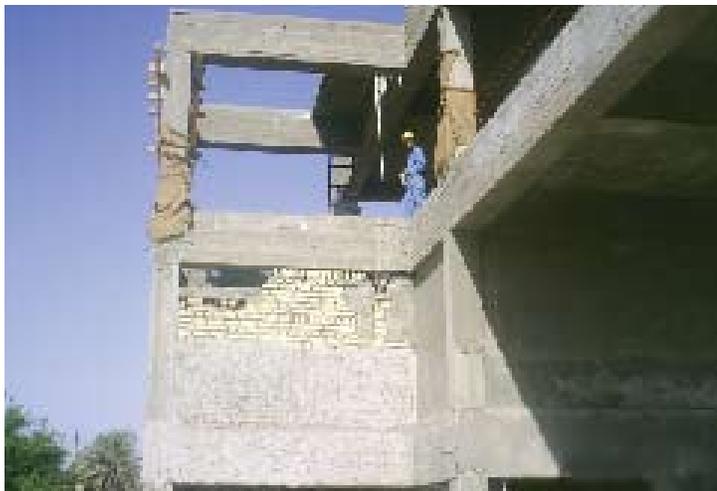
Fire station under construction

segregation, though SIGIR did not document the entire facility. Interior and exterior block walls were partially complete with external plastering in progress. Installation of window frames on the first floor rear of the building was ongoing. SIGIR noted no discrepancies.

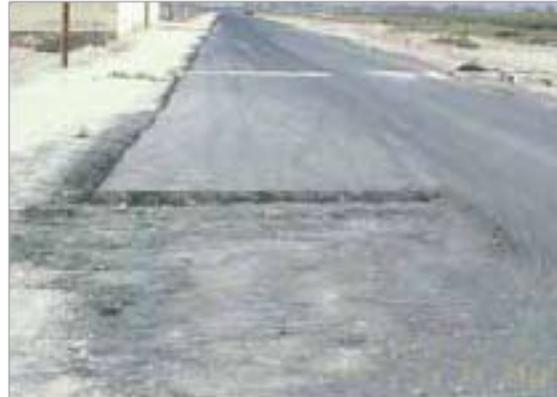
At the Basrah road project locations, the survey team verified road construction was in progress at the time of the visit. Installation of the sub-base and asphalt surface appeared to be consistent with the design requirements. Additional road surface and shoulder work was still required at the time of the visit. SIGIR did not note any major discrepancies. The Thi-Qar road project was reported to be 100% complete, but this could not be verified by the survey team. SIGIR observed recent road grading in the vicinity of the project; however, new asphalt was not in place. This project will be further evaluated by an in-depth SIGIR Inspections team during the next quarter.

Asphalt surface of Basrah road project

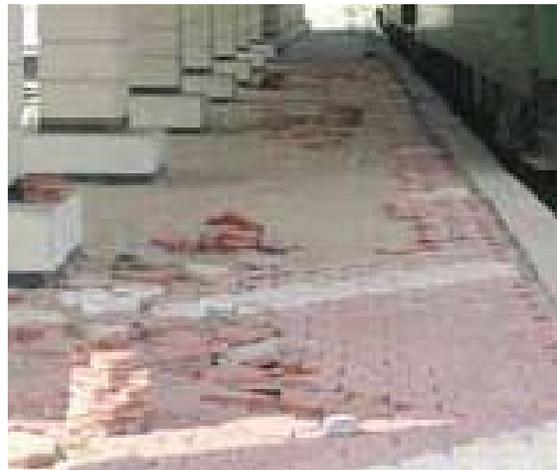
The Basrah Railway Station renovation project was in progress at the time of the limited on-site inspection. Placement of exterior patio brick over sand base was

Installation of brickwork

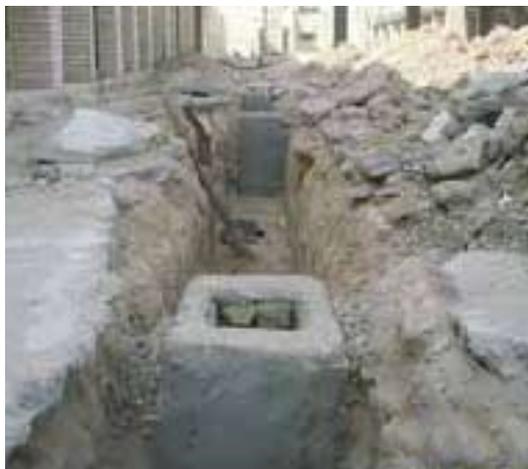
Manholes and excavation work

partially complete. The survey team observed brick and cement manholes and trenches between the manholes. Minor electrical work had also begun. SIGIR noted that manholes were of poor quality, wiring on the exterior of the building lacked conduit, and in some places wiring hung freely and passes through windows. Tiles were also missing from the hanging ceiling.

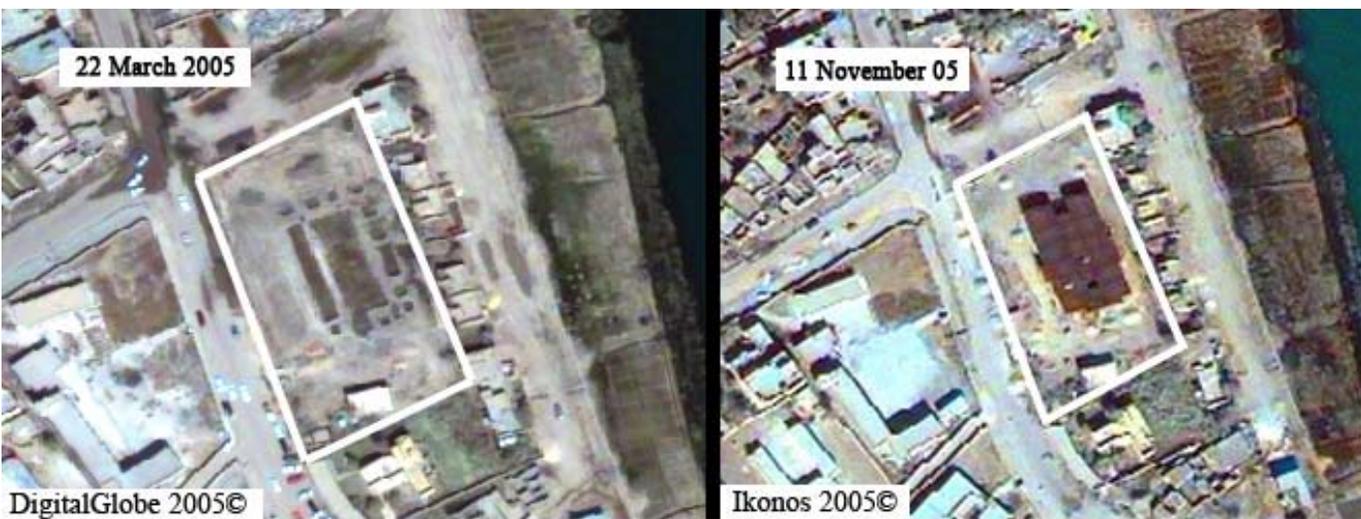
Images 7 and 8. Comparison of imagery showing progress made at another public health clinic in southern Iraq between March 22, 2005 (left) and November 11, 2005 (right). The imagery on the left shows the ground preparation before construction, and the image on the right shows the completed structure of the clinic. There were no visual indicators that the project was behind schedule or that it would not meet contract requirements.
